MINSI DAM

PHASE I INSPECTION REPORT NATIONAL DAM INSPECTION PROGRAM

6 National Dam Inspection Program. Minsi
Dam (NDS ID PA 00788 DER ID 48-139),
Delaware River Basin, East Branch
Martin's Creek, Northampton County,
Pennsylvania. Phase I Inspection Report.

11 JUNE 1979

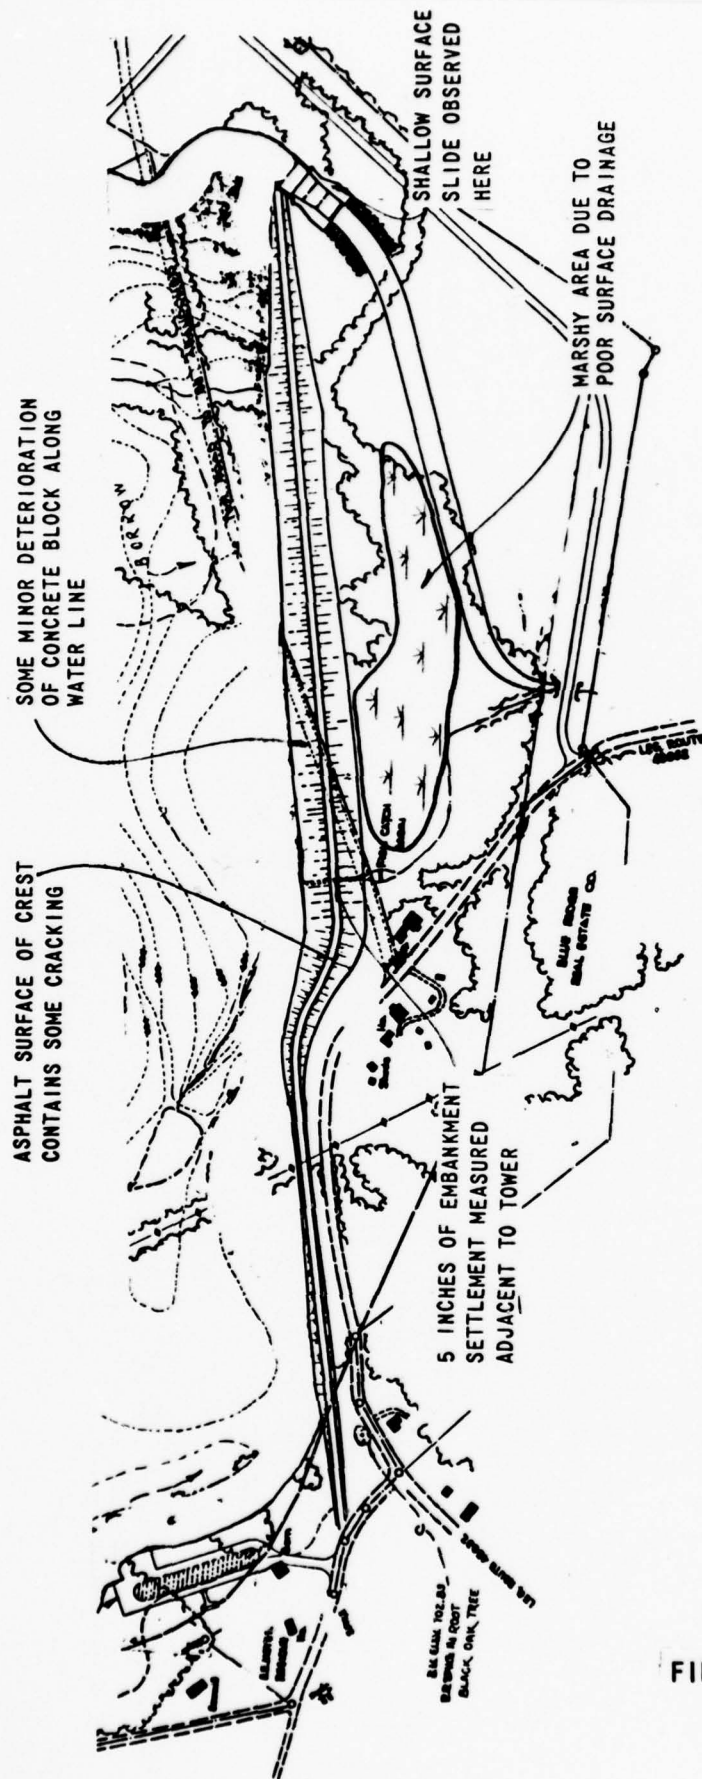
SHEET 5A OF 11

In summary, visual inspection of the structure disclosed no evidence of apparent past or present movement of the dam or its appurtenant facilities. Seepage or wet areas noted along the downstream toe, as shown on sheet 5a, were traced and assessed to be from natural drainage toward the toe of the dam, possibly from natural springs which are common to this swampy area.

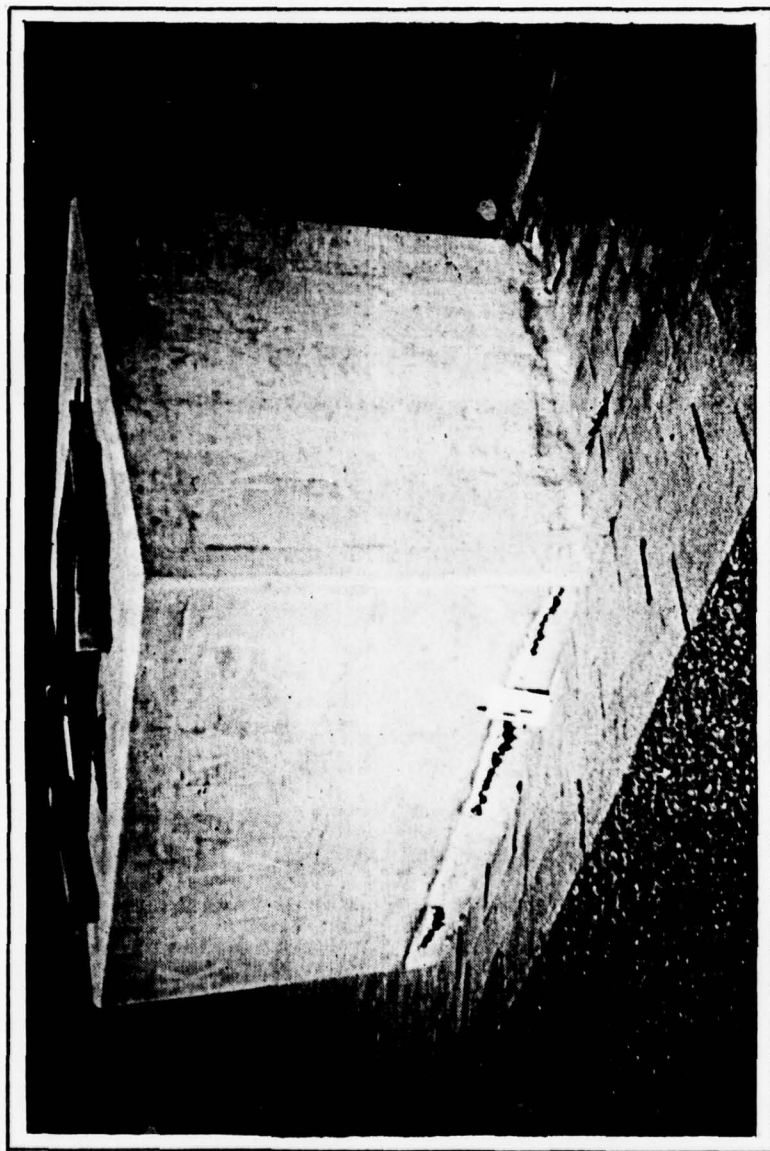
PHOTOGRAPH NO. 1

1. Intake Tower. Exposed portions of the intake tower and outlet structure were inspected and found to be in good condition with no significant spalling, cracking or concrete deterioration. The outlet channel was inspected and found to be in good condition.

OVERVIEW OF PRINCIPAL SPILLWAY
INLET STRUCTURE.

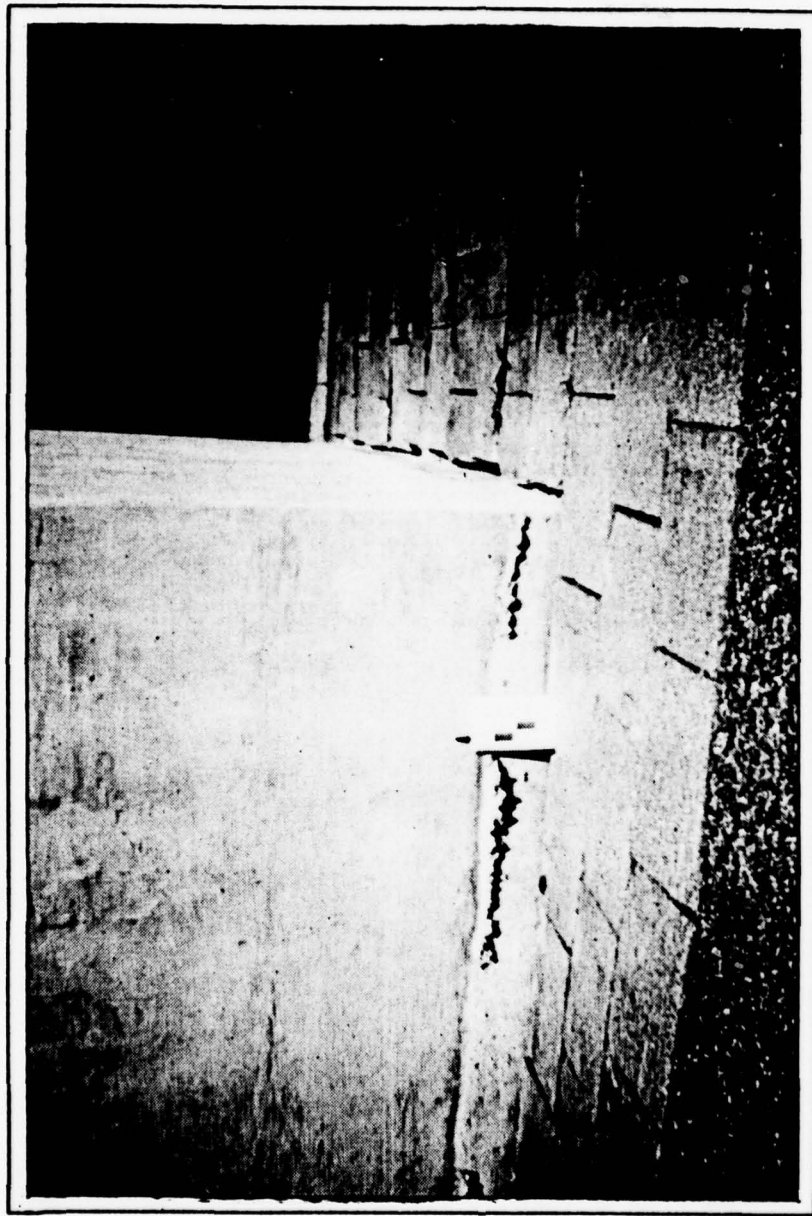
PHOTOGRAPH NO. 10

a. Visual Observations. Field inspection disclosed no evidence of potential instability of the embankment or its components. Embankment slopes are reasonably uniform with no signs of displacement or sloughing. Settlement of the embankment on the order of five inches was noted adjacent to the control tower. Considering the compaction problems noted and discussed in Section 3, this settlement could be expected.

SETTLEMENT AROUND THE PRINCIPAL
SPILLWAY INLET TOWER. SETTLEMENT
AVERAGED ABOUT FIVE INCHES.

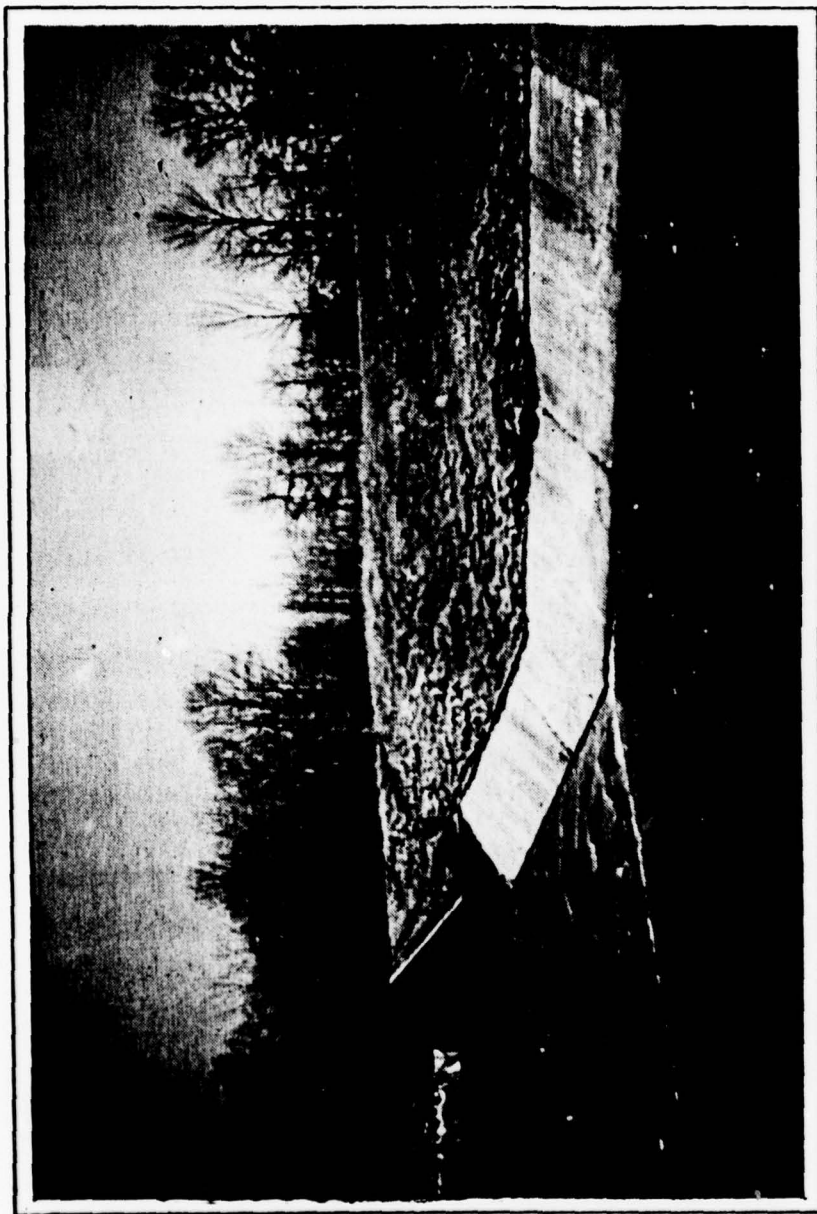
PHOTOGRAPH NO. 11

2. Emergency Spillway. The emergency spillway was observed to be in good condition with no signs of cracking, spalling or concrete deterioration. There was one small shallow surface slide noted on the left cut slope just downstream of the emergency spillway, but this has no effect on the ability of the spillway to pass flows.

SURFACE SLIDE ON CUT SLOPES, LEFT
SIDE OF EMERGENCY SPILLWAY.

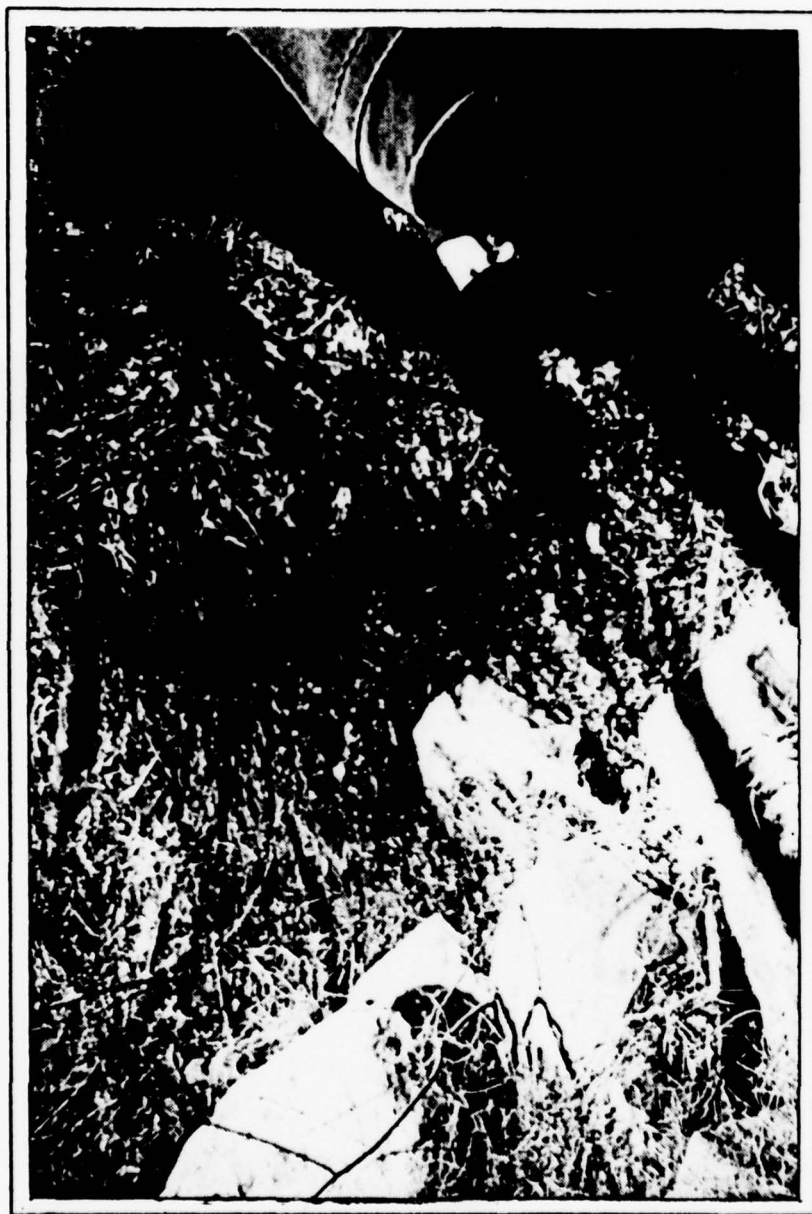
PHOTOGRAPH NO. 14

There was no exterior evidence indicating abnormal seepage through the embankment. Wet zones at the downstream toe were traced to topographic conditions where surface runoff drains towards the toe of the dam.

STAGNANT WATER ALONG THE TOE OF
DAM CAUSED BY POOR SURFACE DRAINAGE
AWAY FROM STRUCTURE.

1. The marshy area at the toe of the structure should be regraded and drained away from the dam. Subsequently, seepage should be monitored to determine whether it flows through the embankment. Should it be determined that seepage flows through the embankment, appropriate remedial measures should be taken to control this flow.
2. Concrete block on the upstream slopes should continue to be monitored, especially during the spring of each year. Deteriorated block should be removed and replaced with new block.
